## CRANLEIGH TELEPHONE KIOSK (Alfold Road)

### 1 INTRODUCTION

The red telephone box at the junction of Elmbridge Road and Alfold Road in Cranleigh dates from the period 1953 – 1955. I inspected the box in late December 2020 and this report covers my appraisal of its condition, suggested work to be carried out and my likely charges to carry out the work.

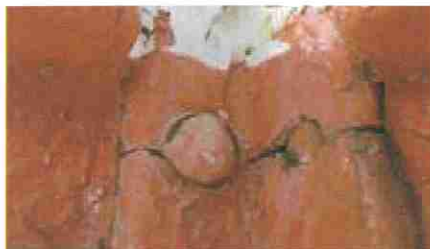
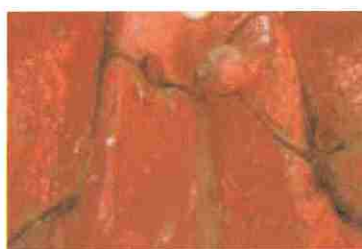
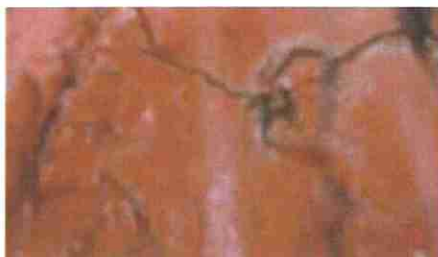
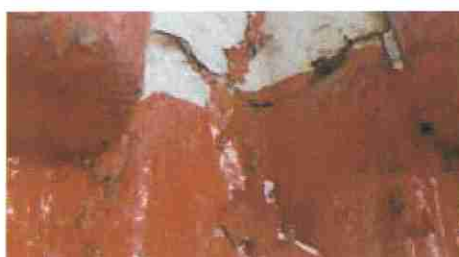
#### 3.1 BROKEN CORNER POSTS

The tops of all 4 corner posts are broken. It is most unusual for all of these to have broken unless either an attempt has been made to lift the box via a crane with the lifting strop positioned through the openings for the transom signs or the box has perhaps been hit some time ago by a large vehicle.

In effect there is actually very little holding the whole top of the box to the rest of it although it cannot come off (unless an attempt is made to crane it up) due to the weight of it and the way all the panels are fitted together.

Rust is forming between the panels and will try to force the outer panels away from the posts as the rust expands over time.

All the paintwork will need to be removed to reveal the full extent of the problem and to enable the best solution to be ascertained. The breaks can be welded up but this is not an easy task and it is unlikely to be as strong as an unbroken panel. All joints will need fully sealing to try and prevent further ingress of condensation and dampness but it will not be possible to remove the rust between the joints.

All of the surrounding area around the breaks/cracks will need cleaning right back to bare metal to allow the full extent of problems to be revealed. The breaks will need to be welded up as far as possible. Additional strengthening pieces may need to be fitted at some of the broken corner posts.

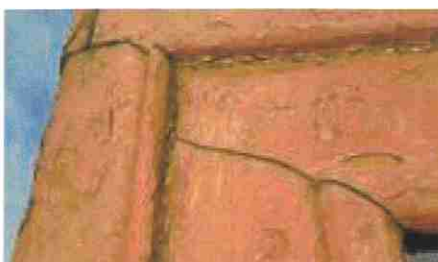
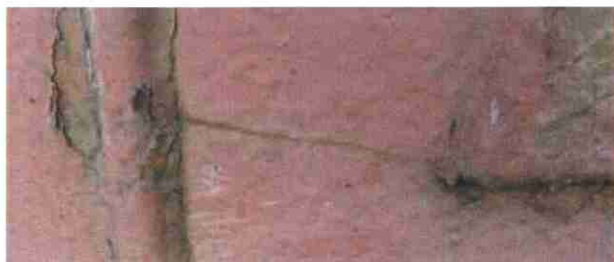
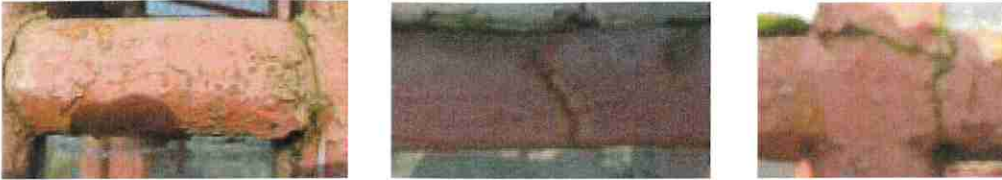
#### 3.2 CRACKS IN SIDE PANEL

The RH side panel is cracked/broken in 2 places. In addition, at least 3 glazing bars are broken. These will all need welding up. It is difficult to get a really good weld on these as the cast iron should ideally be extensively pre-heated. The repair will be strong enough but it is possible that some small cracks may reappear in the future due to the slight expansion of the metal in hot sunshine.

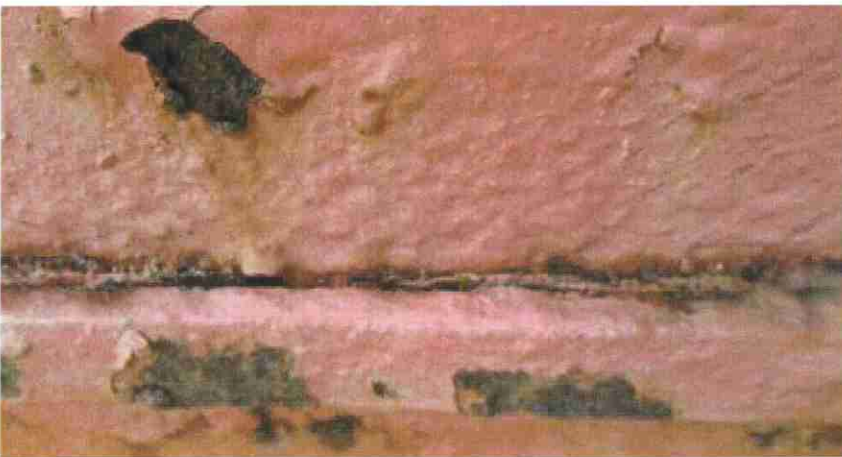
### **3.3 REAR PANEL**

The rear panel is a replacement that has been made out of fabricated steel rather than cast iron. The original panel may have been broken during an attempt to prise the cash box away from the panel or perhaps the panel was hit by a large vehicle and the corner posts were broken at the same time. Extensive rusting is taking place between the panel and the bottom decorative moulding strip attached to it. The strip is starting to be pushed away from the panel by the rust. The surface rust will have to be removed but it will not be possible to eliminate all the rust between the panel and the strip. The slight gap that has formed will need filling.
