## **Tree Hazard Assessment Survey & Condition Report – Cranleigh Parish Council – Summer 2025:**

Cranleigh Parish Council Sites

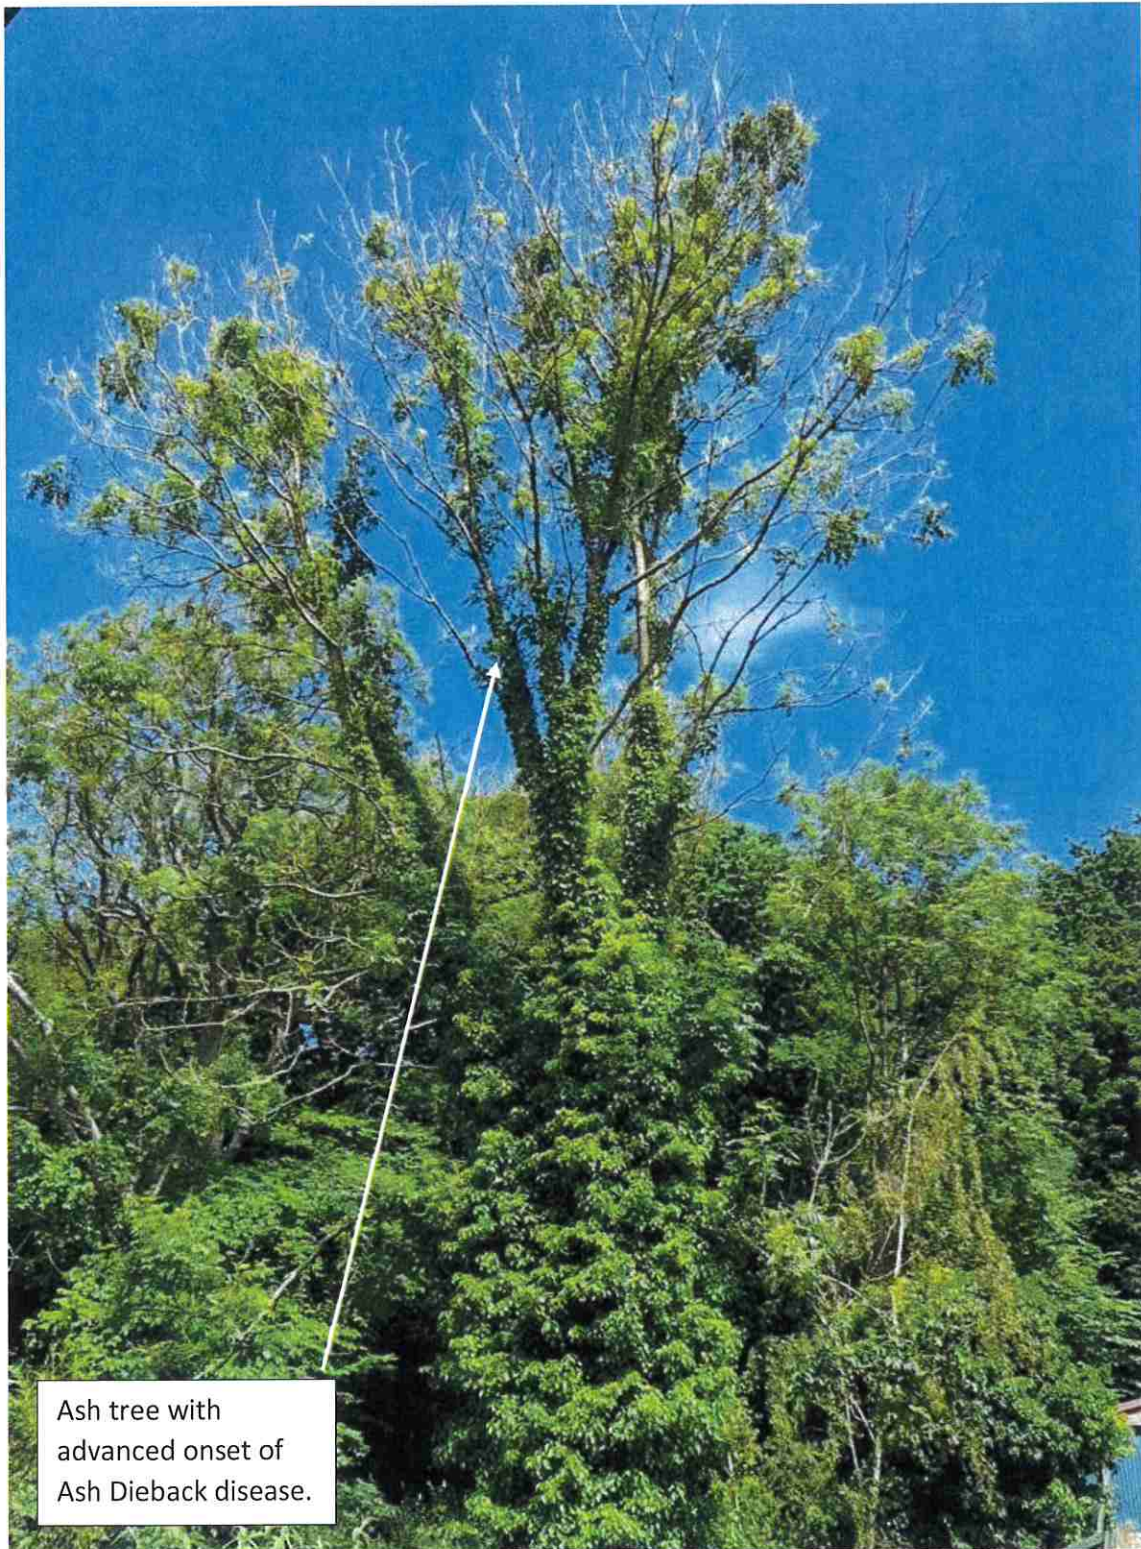
Ash tree with  
advanced onset of  
Ash Dieback disease.

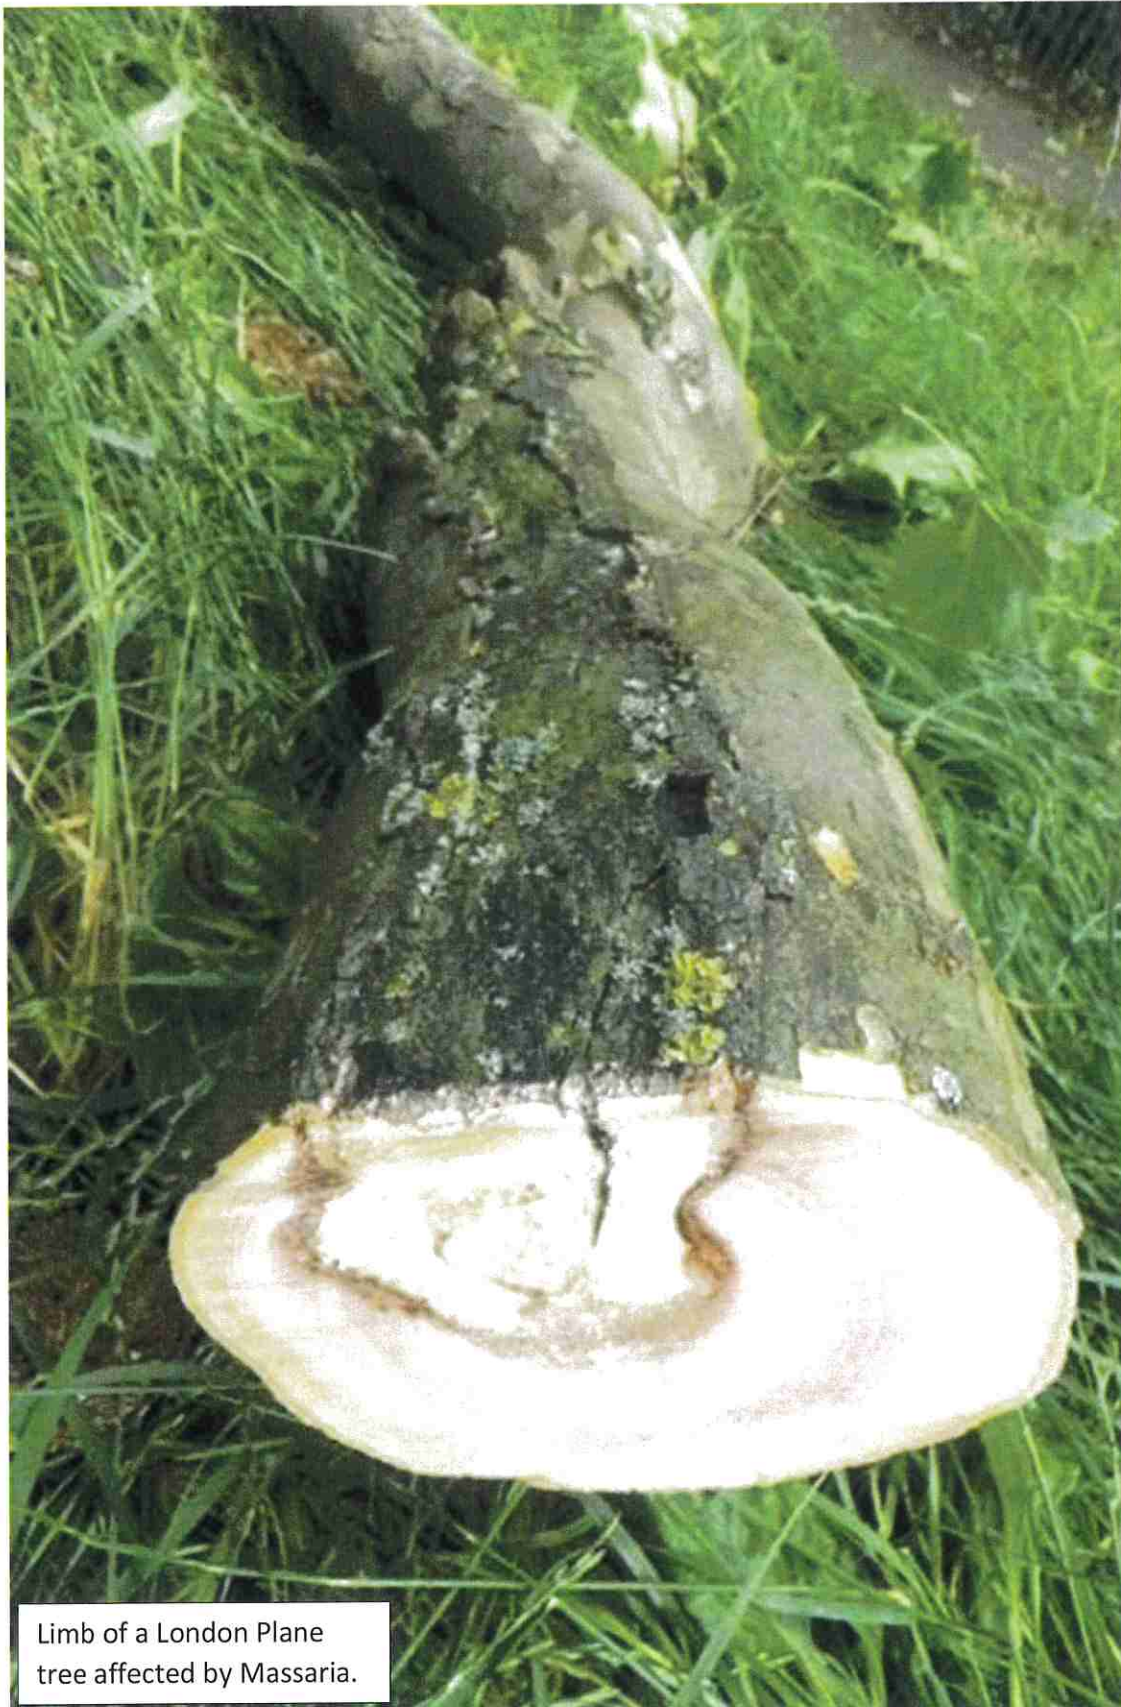
Limb of a London Plane tree affected by Massaria.

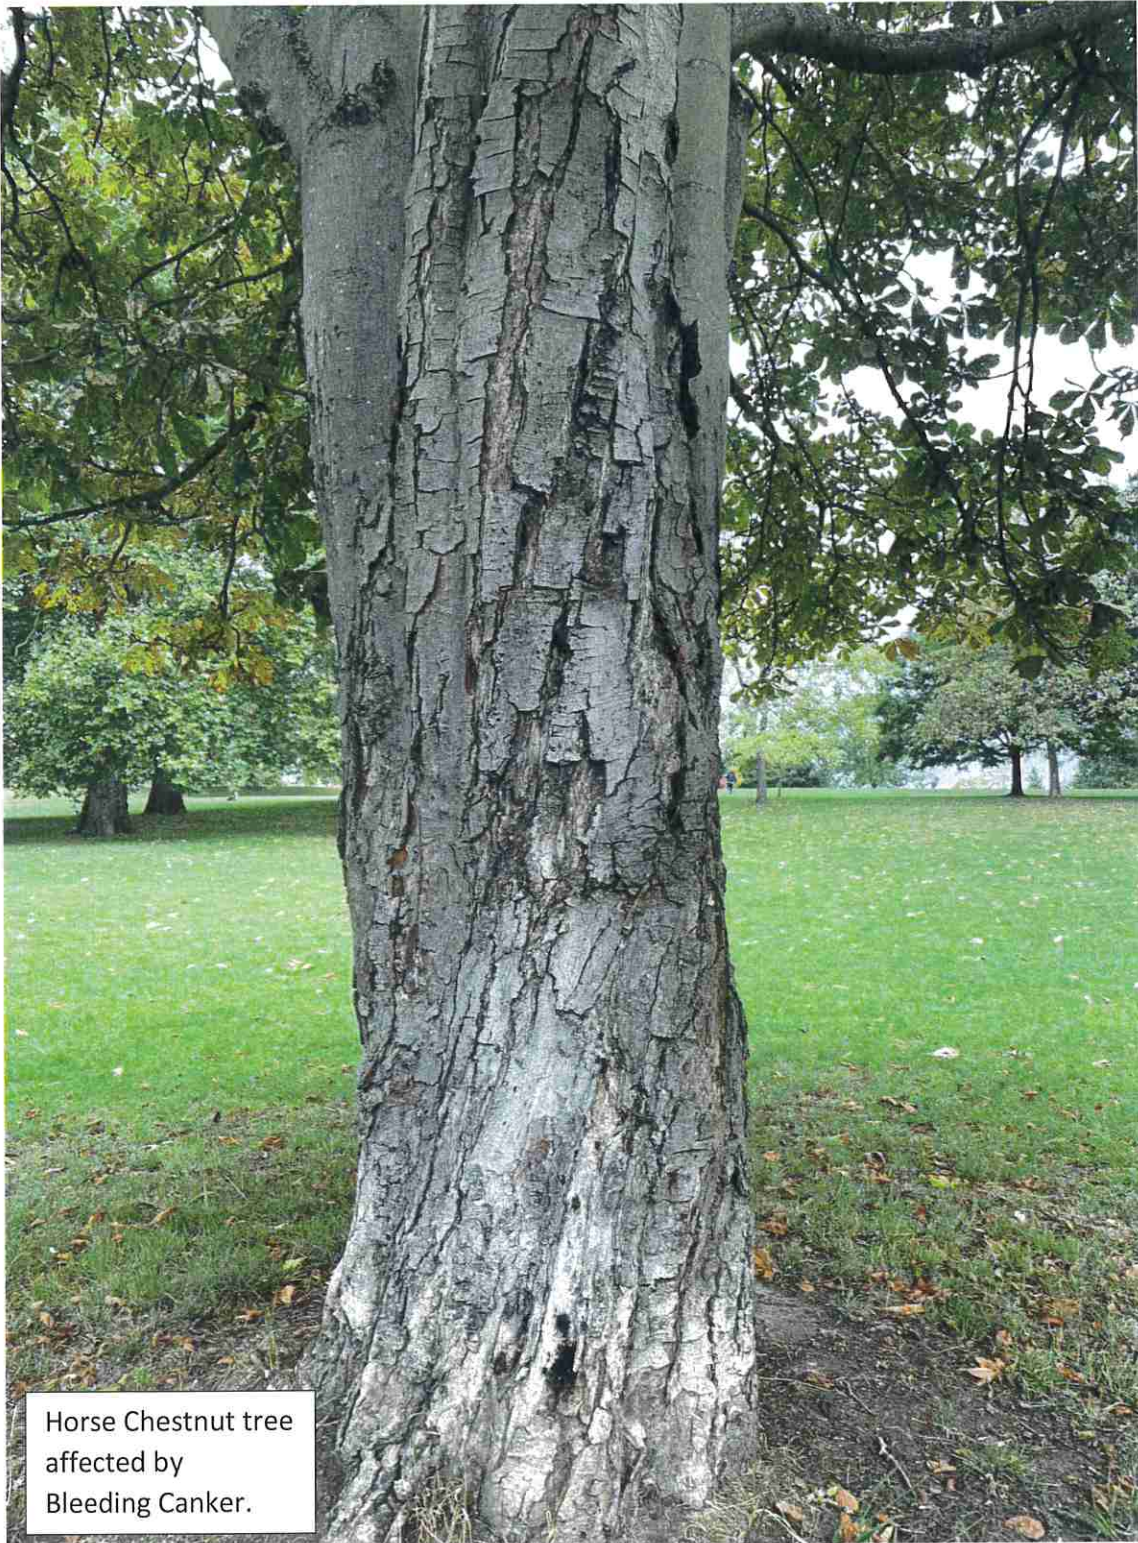
Horse Chestnut tree  
affected by  
Bleeding Canker.
