**Public Footbridge south of Village Way**

**Design and Access Statement**

**To accompany a Full Planning Application for a replacement public footbridge**

Applicants: Cranleigh Parish Council

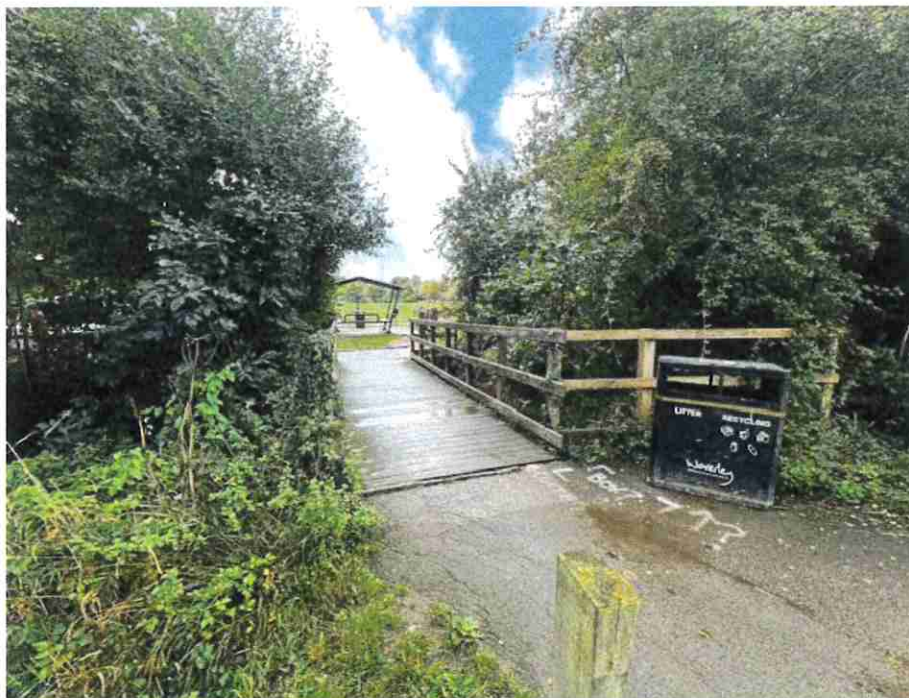
Fig 2: Existing bridge looking south towards the Snoxhall Fields

4.1 The existing structure is a timber framed bridge which spans north-west, with timber framed post and rail handrail and timber slatted board floor finished in felt grip adhesive. The structure finishes abutting a tarmac pathway on both the north and south sides.

4.2 The existing structure is in a very poor condition, with several structural timbers heavily eroded and no longer fixed. Resulting in a spongy feel when crossing the bridge, and several timber boards which dip down when walked on causing a trip hazard.

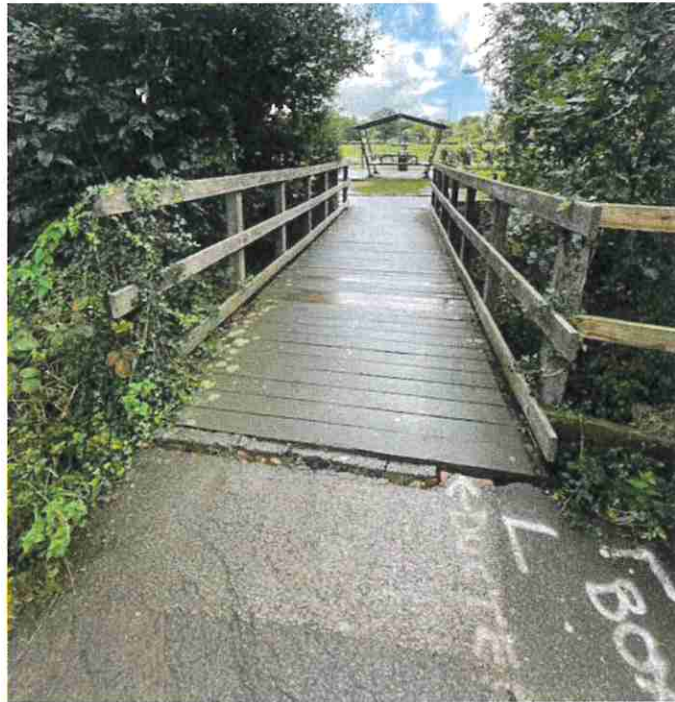
Fig 3: Existing bridge looking south towards the Snoxhall Fields, showing the tarmac pavement cracking at abutment with the bridge

4.3 The tarmac to the north side of the bridge is falling away from the bridge where the structure below is unsound. This has resulted in a substantial gap between the flooring, causing further potential trip hazards.

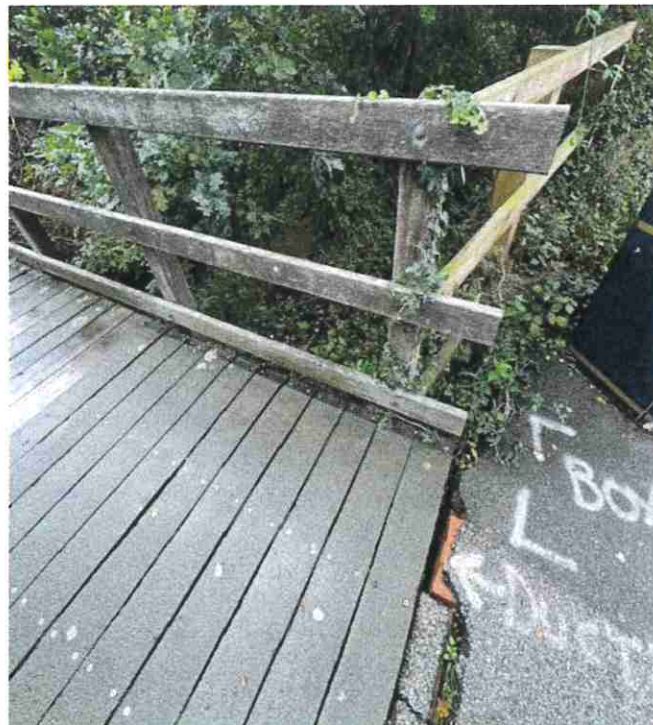
Fig 4: Existing bridge showing the tarmac pavement cracking at abutment with the bridge

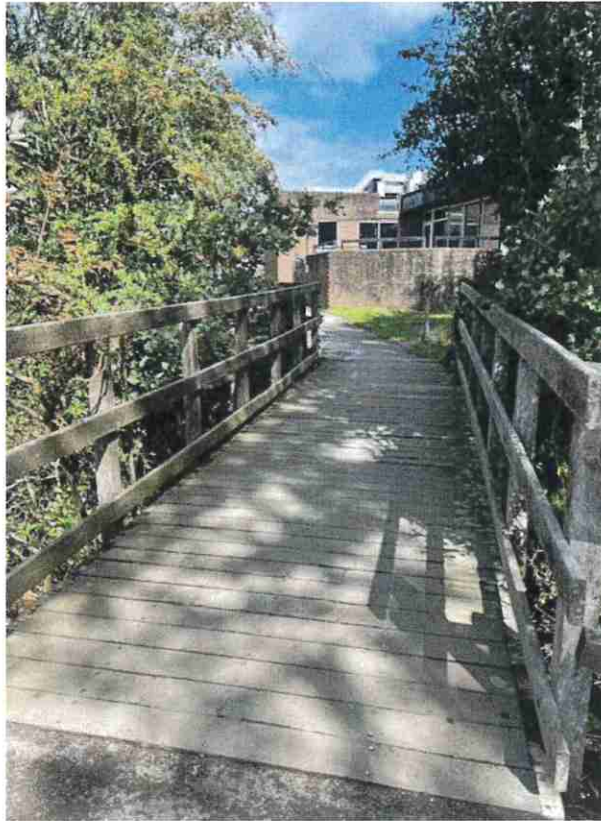
Fig 5: Existing bridge looking north towards Cranleigh Leisure Centre.

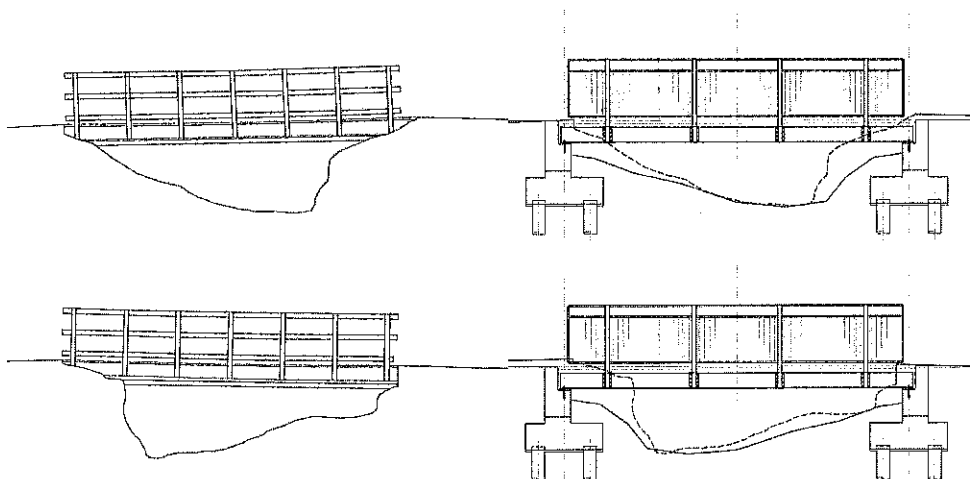
1. the proposal includes steel frame balustrade with mesh infill panels, which will be part of the structure of the bridge.

Fig 6: Existing and Proposed east and west Elevations

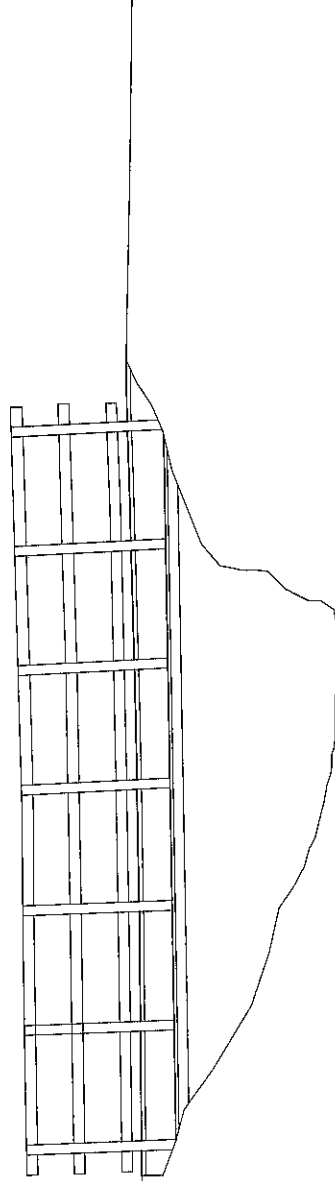
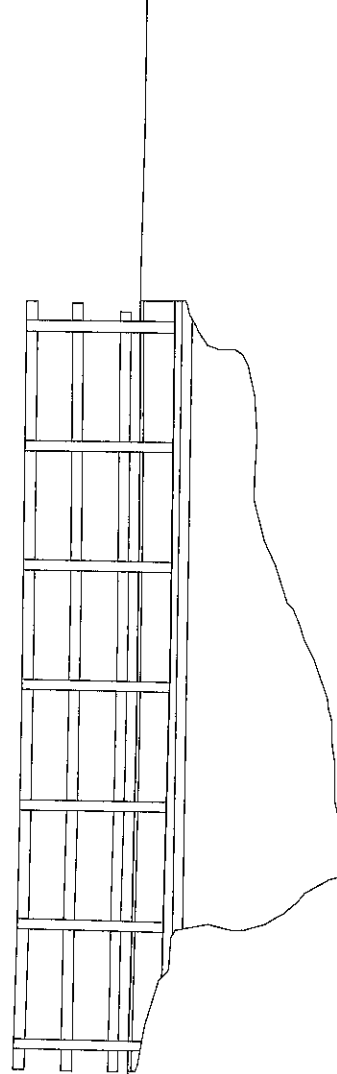
Existing Elevations

East Elevation

West Elevation
