project  
CRANLEIGH VILLAGE HALL,  
VILLAGE WAY,  
CRANLEIGH,  
GU6 8AF

drawing title  
**PROPOSED STAGE FLOOR**

rev	description		date
Drawn TW	Scale 1:50		
Date April 2024	Scale As stated at A3		
Job No <b>21995</b>	Drg No <b>101</b>	Rev

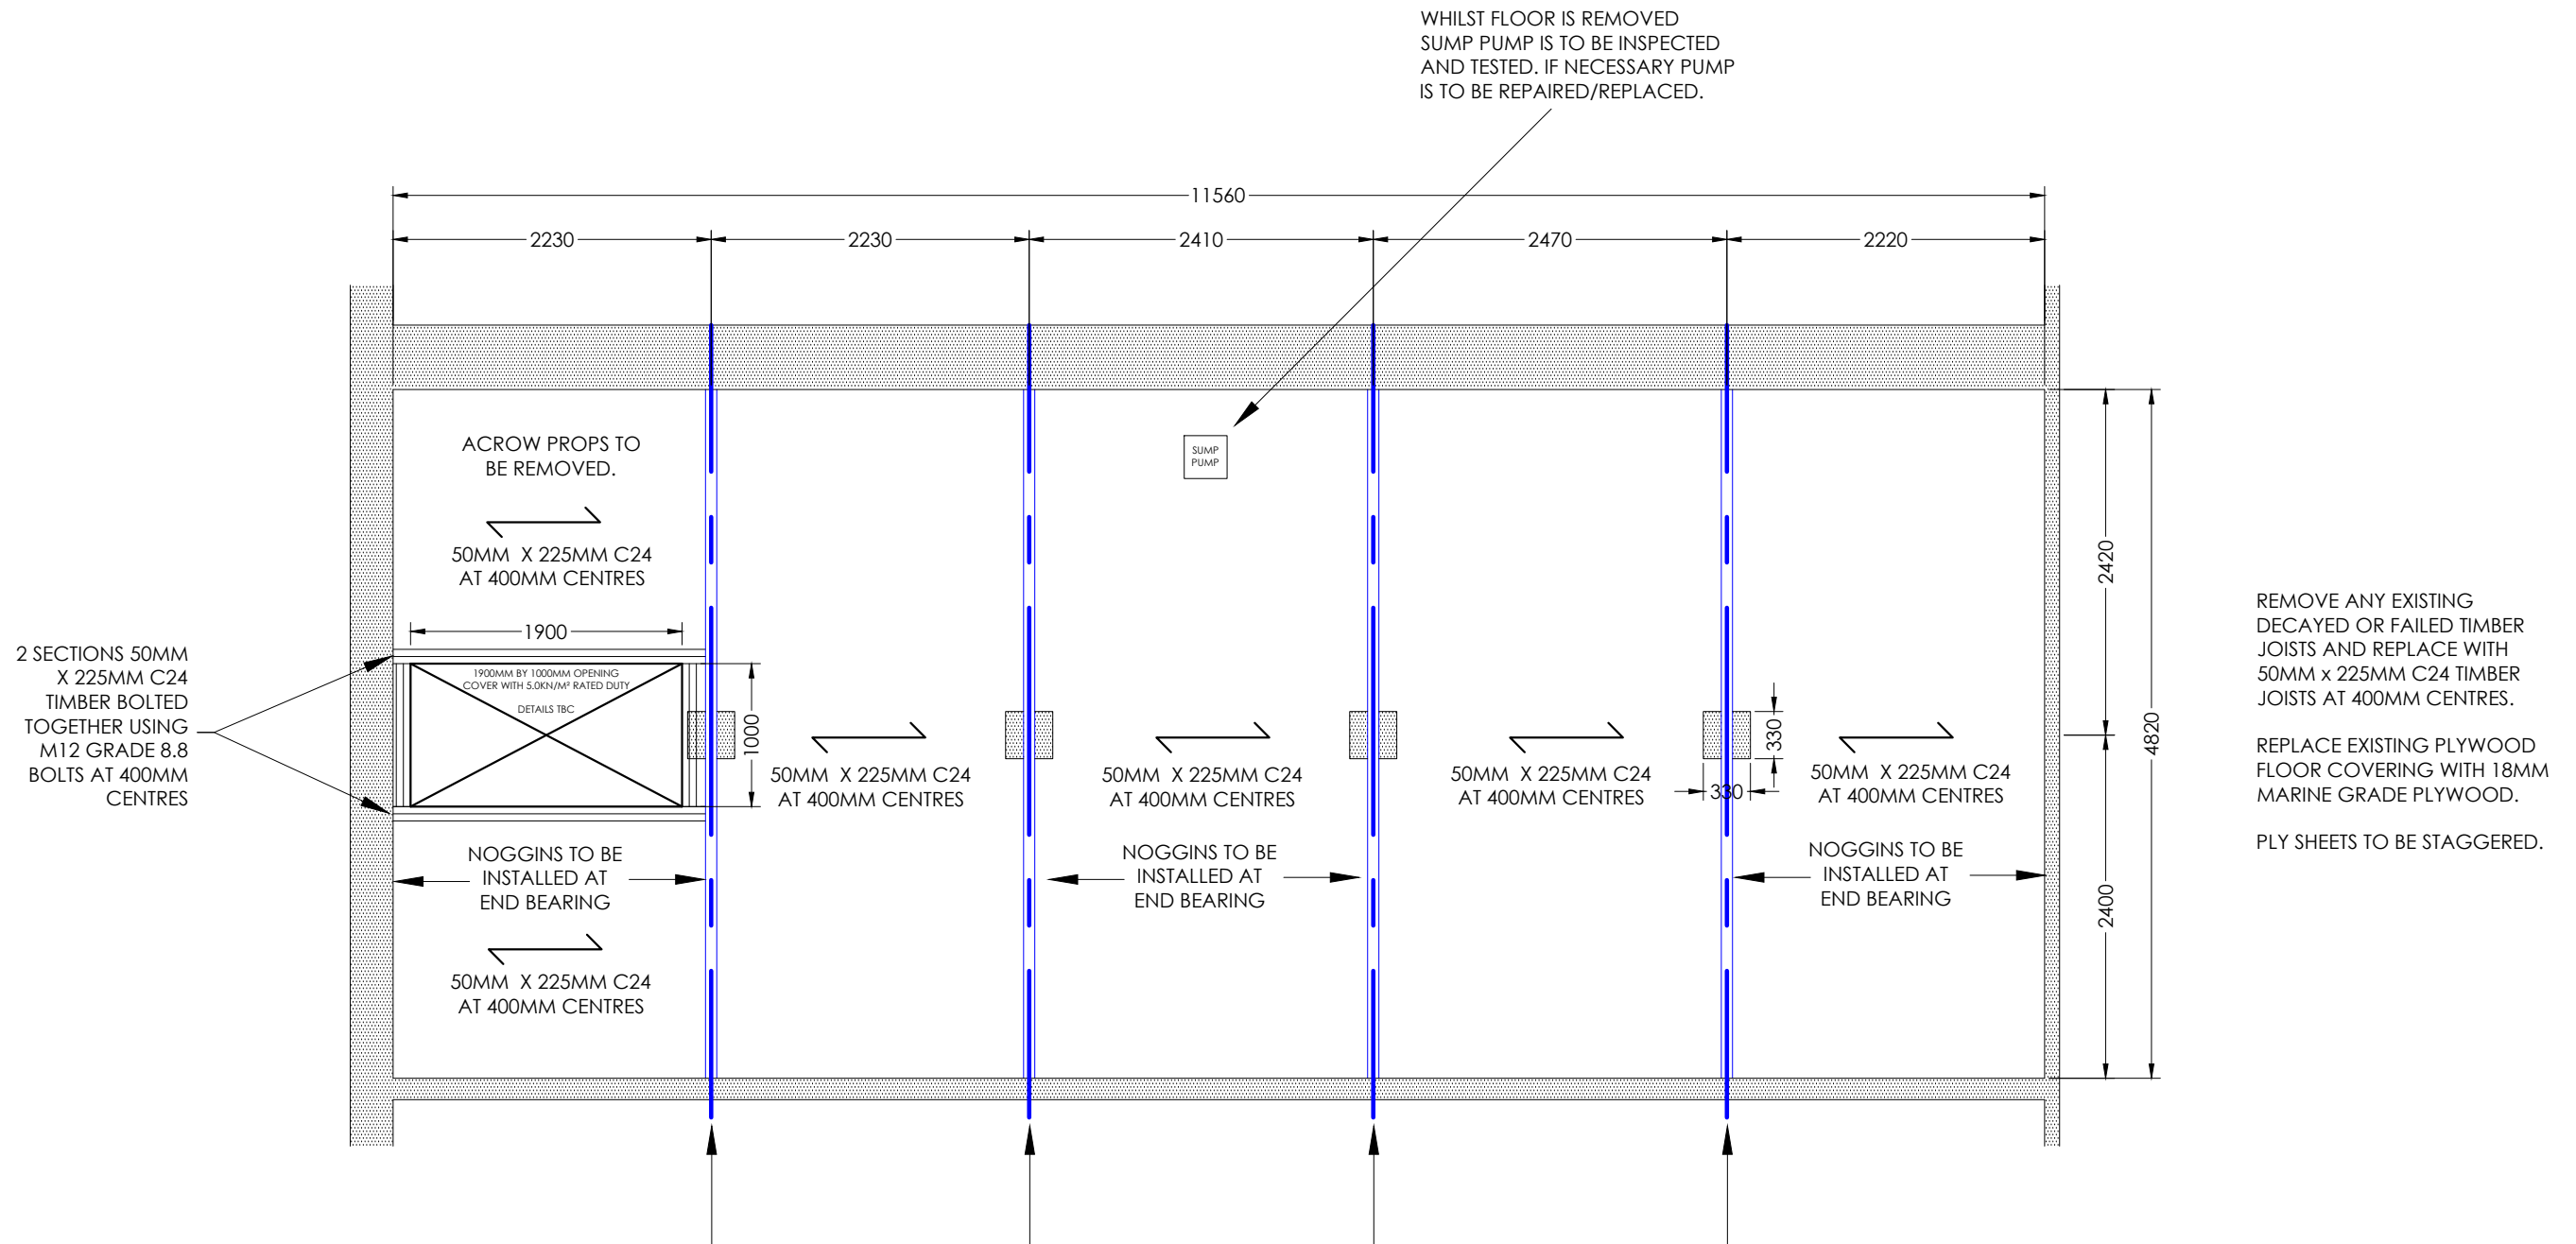
ONCE THE EXISTING FLOOR COVERING HAS BEEN REMOVED, WIRE BRUSH BEAMS FOR INSPECTION BY A STRUCTURAL ENGINEER PRIOR TO PAINTING. ALL STEELWORK IS TO BE PAINTED TO ACHIEVE A LIFE TO FIRST MAINTENANCE OF 20 YEARS. DETAILS OF THE PROPOSED PROTECTION SYSTEM IS TO BE COMPATIBLE WITH FIRE PROTECTION SYSTEM. APPLY PROTECTIVE ZINC RICH COATING TO THE STEEL BEAMS. ALL STEELWORK IS THEN TO RECEIVE 2No. COATS OF BITUMINOUS PAINT 150 MICRONS DRY FILM THICKNESS.

**NOTE:**  
5.0KN/M² IMPOSED FLOOR LOAD
